PRECISION
ENVIRONMENTAL SERVICES INC.

Radon Test Report

November 23, 2022
Batch #: 112322-2

Test Site:
Mr. Jones
xxx Apple St
Mokena IL 60448

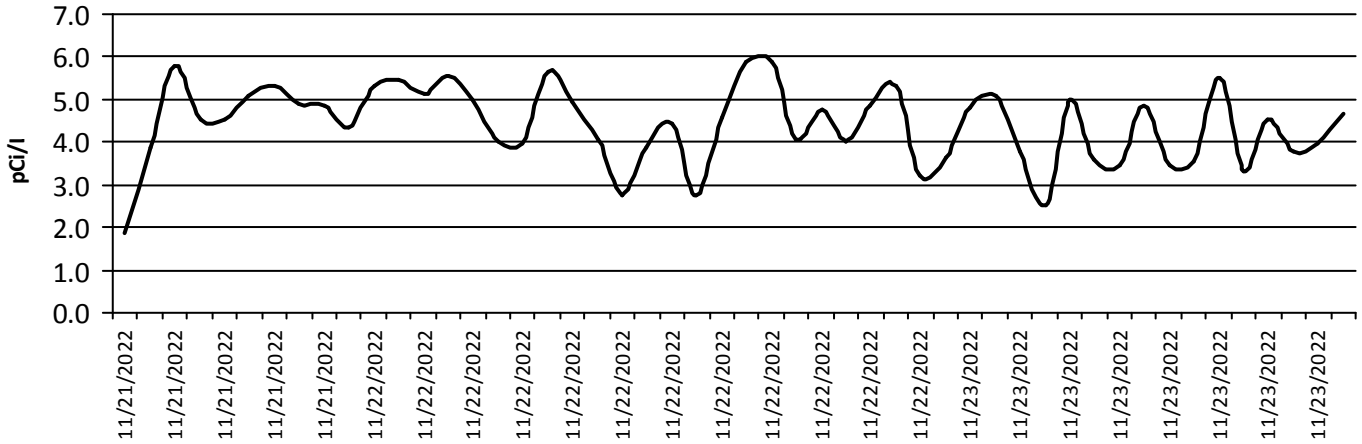
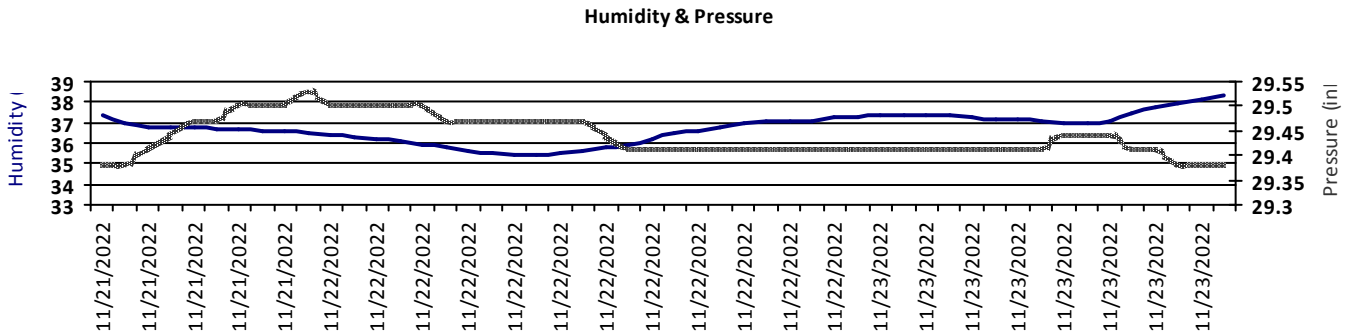
Graphical Results for: Rad Elec Recon 293

Average Radon Concentration in: Basement **4.4 pCi/L**
